Reglet Flashing Detail
Scale 3"=1'

Description: Spanish Tile
Endwall Reglet Flashing Detail

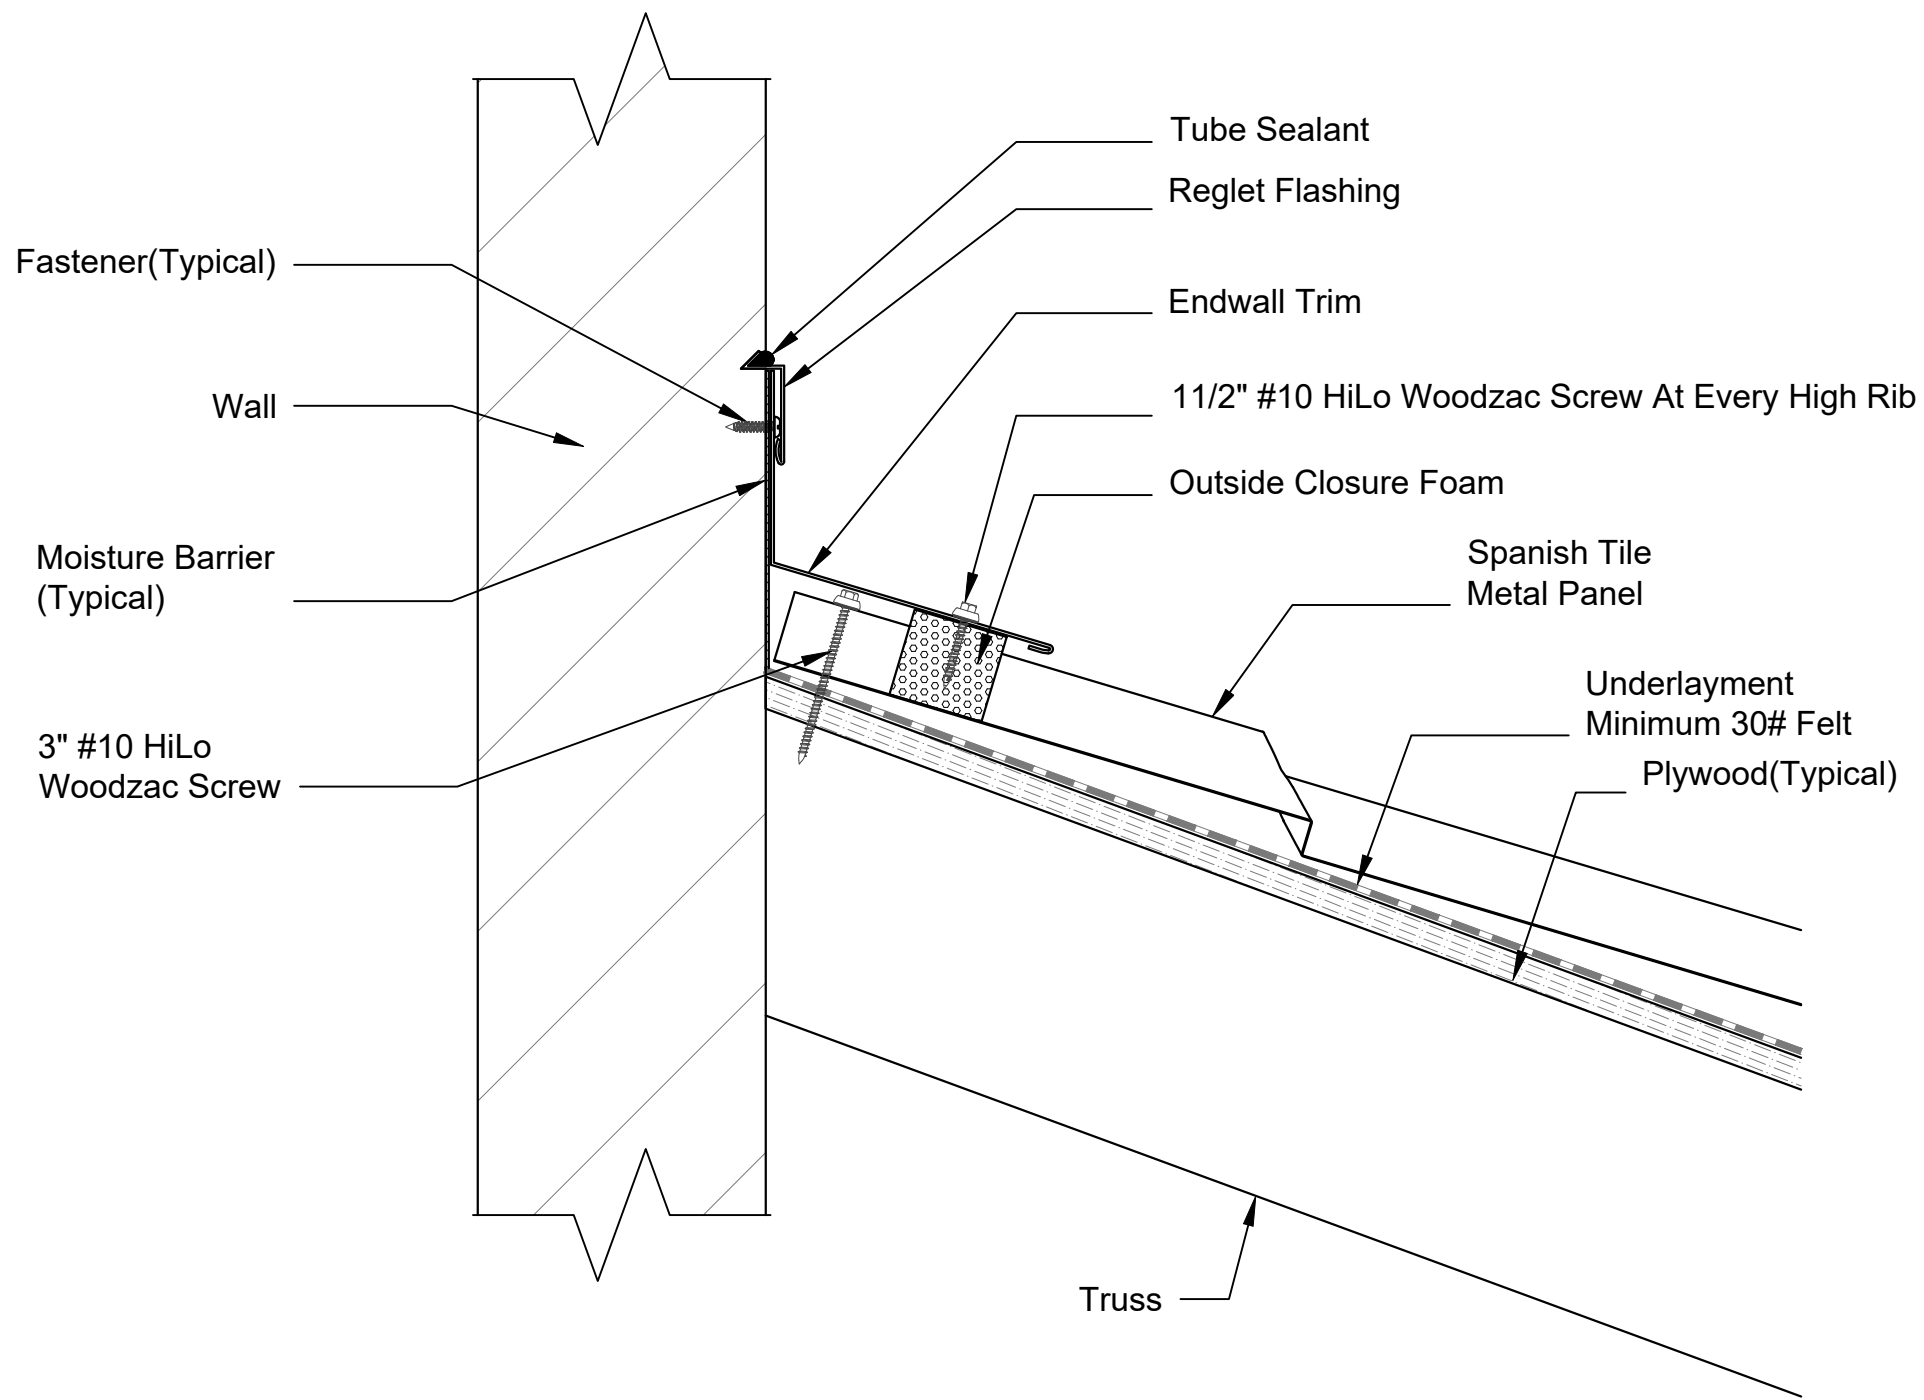
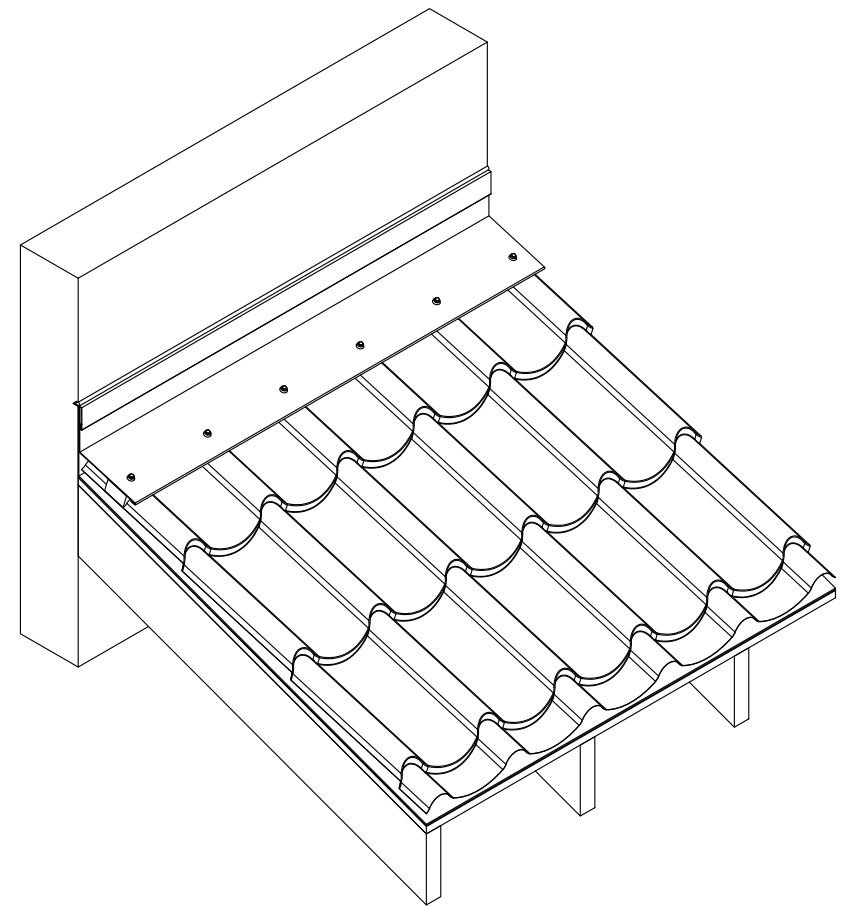
Isometric View

Outside Closure Foam

Closed Hem

Reglet Flashing

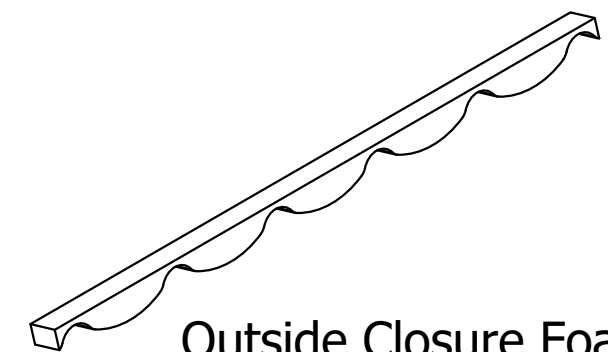
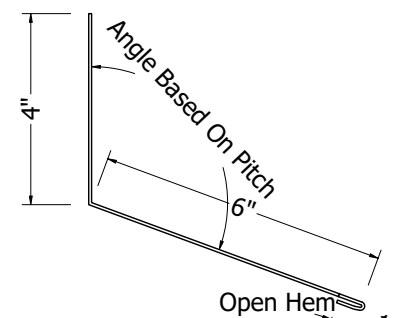
End Wall Trim Detail

Open Hem
